**Mount Washington Alpine Resort Water
System Annual Report 2018**
Mount Washington Utilities Department

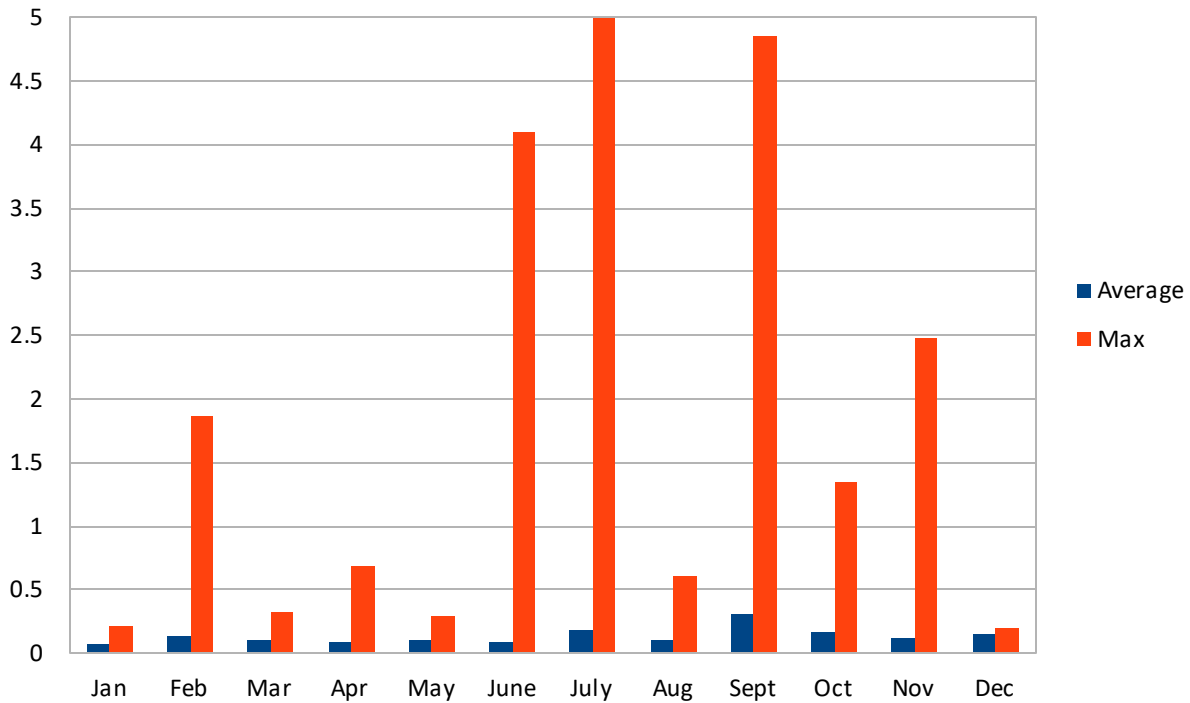
Turbidity is a measurement of the cloudiness of water. Reported in nephelometric turbidity units (NTU), it is an optical measurement of water's ability to scatter and absorb light rather than transmit it in straight lines. Turbidity is caused by fine suspended particles of clay, silt, organic and inorganic matter, plankton, and other microscopic organisms that are picked up by water as it passes through a watershed. It is an important water quality indicator because contaminants such as bacteria and viruses can attach themselves to the suspended particles in turbid water. These particles can interfere with disinfection.

Due to the remote nature of the environment and the quality of the water from our springs, we have consistently low turbidity levels. Occasional high readings are observed, which typically coincide with heavy rain events, storms or rapid spring melts. The very high maximum readings in June, July, and September were caused by servicing and flushing the turbidity meter after events that caused a spike in the turbidity meter. As shown in the graph above, average values are always below 0.35 NTU.

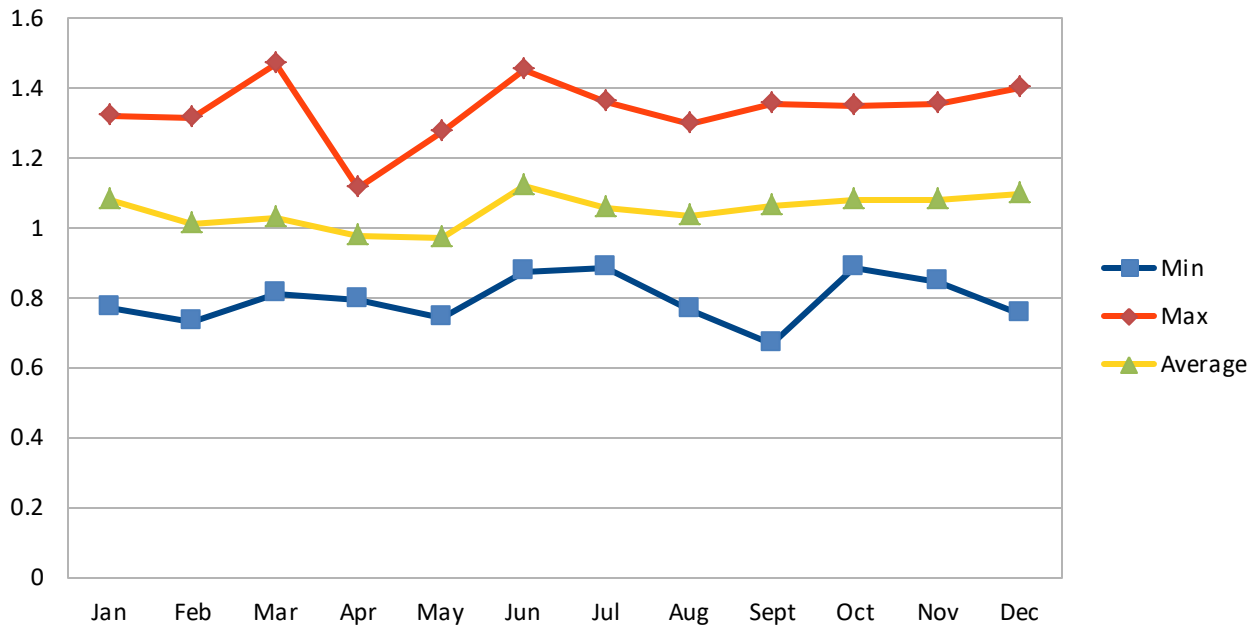
2018 Chlorine Residuals

Sodium hypochlorite is injected into the raw water as it is pumped up to the treated water storage tank. Allowing the solution to mix thoroughly in this tank provides sufficient contact time between the disinfectant and the water. Some of the chlorine is used up in the disinfection process. The residual chlorine is measured continuously by an online analyzer at the water treatment facility, the first tap on the distribution system. Our goal is to meet the 4-3-2-1 guidelines set out by Island Health. We do this in part by maintaining a minimum chlorine residual of 0.50mg/L or ppm at this point at all times. The following graph displays the maximum, minimum and average measured residuals for each month in 2018.

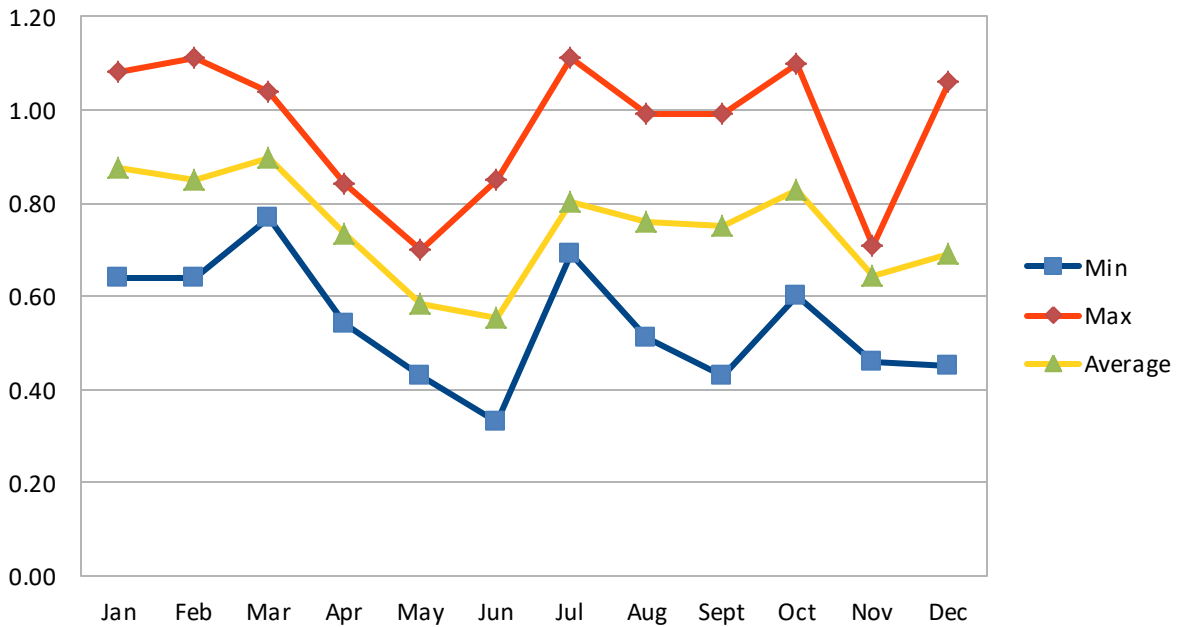
2018 Raven Lodge Residual

The Raven Lodge is the last connection on the distribution system. On a daily basis, we manually test the chlorine residual there with the use of a chlorimeter. The chlorimeter is

used to measure the degree of coloring, and correlates that to a measurement of residual in mg/L or ppm.

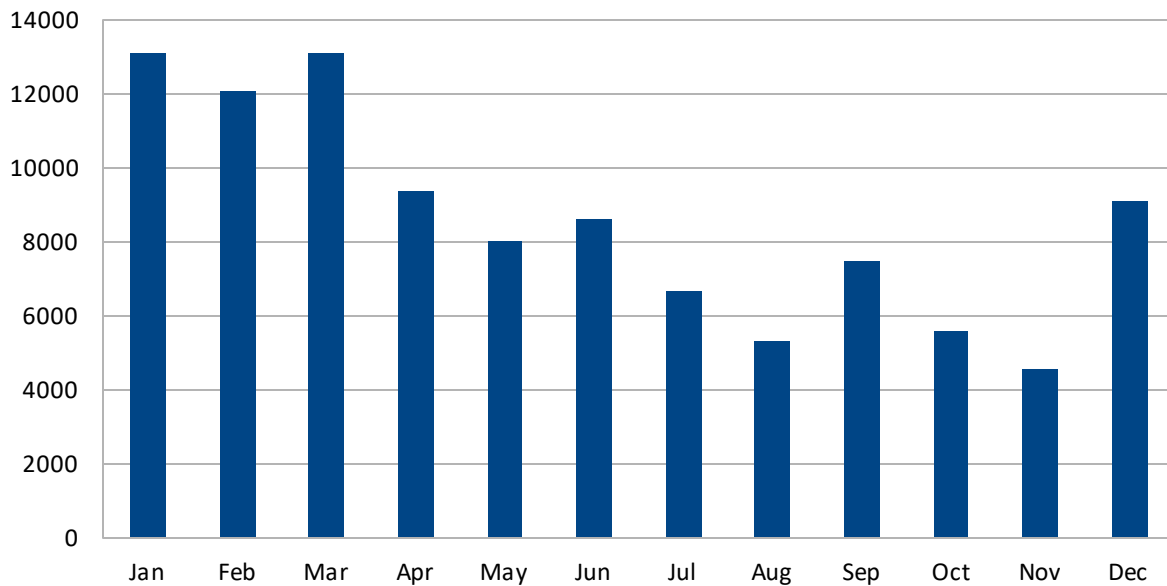
2018 Annual Water Consumption in Cubic Meters

The 2018 winter season was a good winter for snow sports, with a good snow base and favorable weather. The result was higher visitor numbers both in day visits and stays in the village. We also saw an increase in the number of weddings and events being held at the resort during the shoulder and summer seasons, and an increase in the number of mountain bike riders throughout the mountain bike season.
